# CLOS PACHEM

## The construction stages of the building

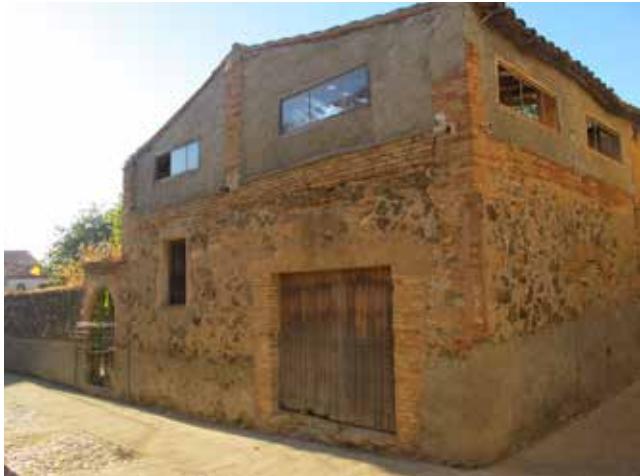
1-2

Initially one third of the building plot was occupied by a derelict building comprising of a ground and first floor (*see photo 1*). The rest of the plot was empty except for some wild vegetation which had appeared over time.

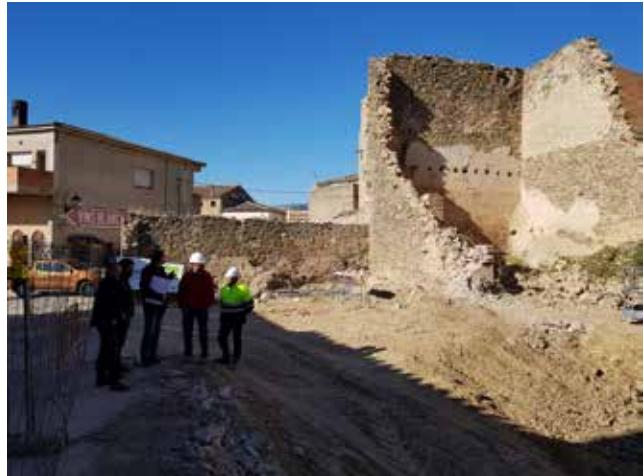
Most of the building was demolished with the exception of the boundary walls and some parts of the wall facing Piró street, with the intention of integrating these into the new building. (*see photo 2*)

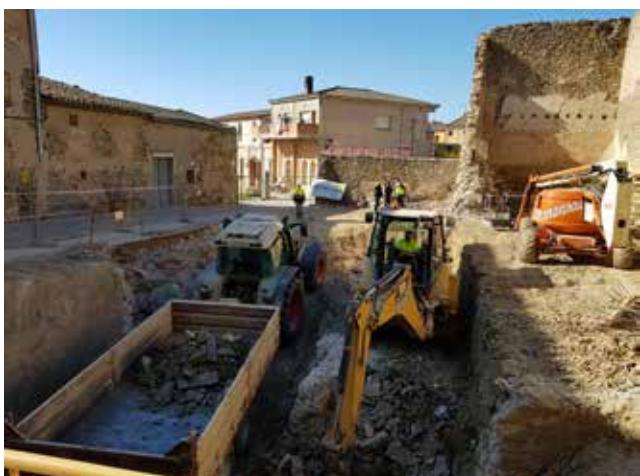
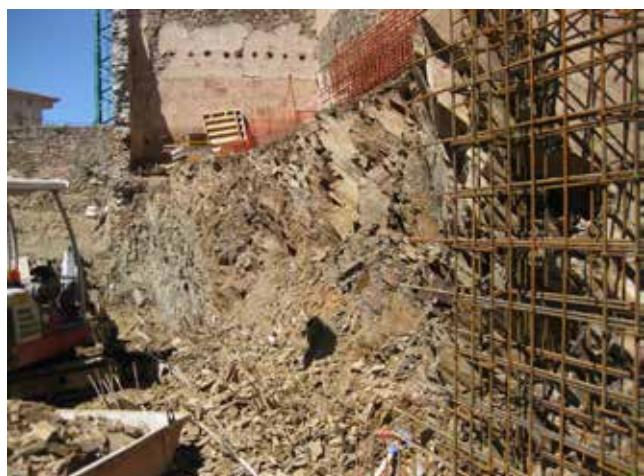
3-4

After demolition, the basement was excavated so that the barrel room and the bottled wine storage area could be built. The instability of the ground, the characteristic Priorat licorella led to some difficulties with regard to the excavation. (*see photos 3, 4*)

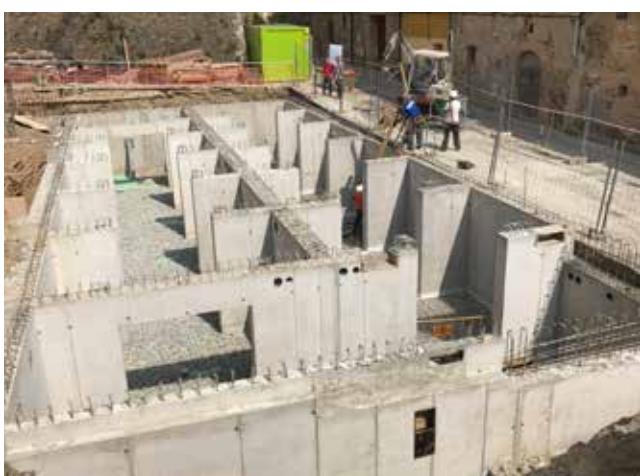
5-6

At the same time, the foundations and retaining walls defining the new basement areas were concreted in a reticulate pattern using reinforced concrete. (*see photo 5*)

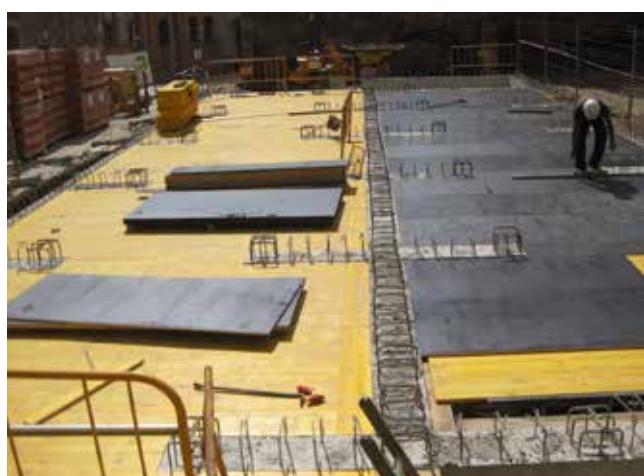
Once completed, these areas were capped by a load bearing reinforced concrete slab with the idea of supporting the future wine tanks to be placed on top. (*see photo 6*)

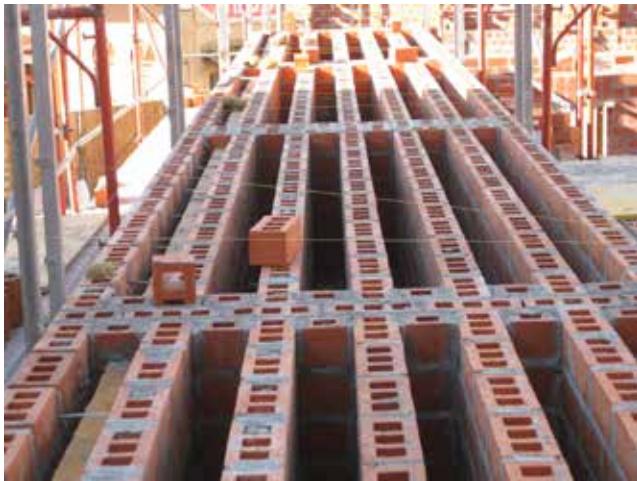
7–8

—In the southern facade, the closure is constructed of 7 ceramic walls in layers, each one 11.5 cm thick and each separated by 13.5 cm spaces, leading to a total thickness of 161cm (*see photo 7*)

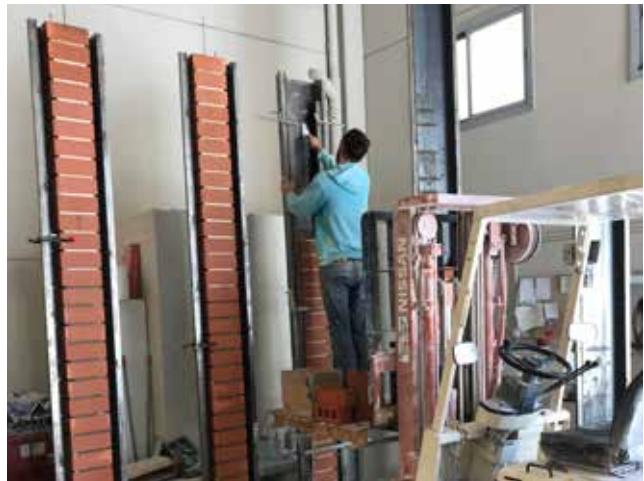
—A total of 721 linear metres of ceramic beams were constructed with the same ceramic bricks as those used in the walls. These beams were first of their kind, requiring various tests and samples to find out the best fabrication procedure to build them (*see photo 8*)

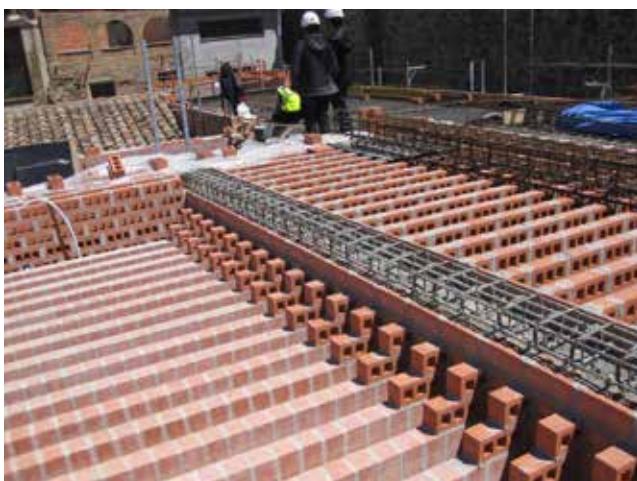
9–10

—The roof of the vault was constructed at 8.75 metres from ground level and is formed by inverted concrete T beams, which are practically hidden from sight, and a truss of ceramic beams over which ceramic walls rest forming a lattice allowing the flow of air. A concrete compression layer above a ceramic pavement forms the top. (*see photo 9*)

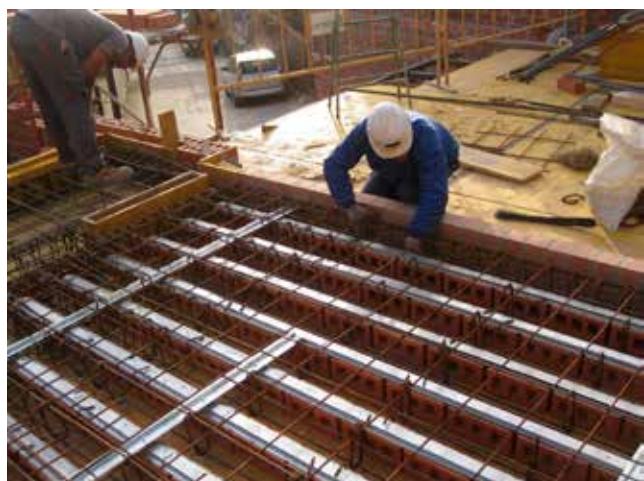
—A novel type of ceramic floors were also constructed, consisting of in-situ concrete webs 17 cm wide, with the 10 cm wide spaces between webs fabricated with the same ceramic bricks used to construct the load bearing walls of the building. (*see photo 10*)

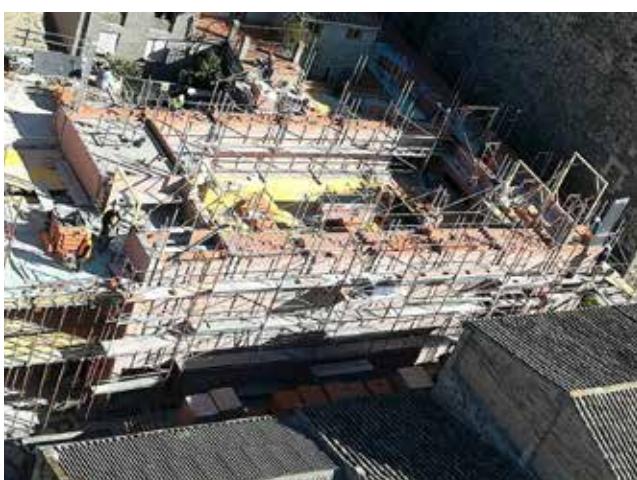
11–12

The ceramic walls of the passage had to be erected simultaneously as they were due to support various interior and exterior flooring slabs. This made for a very vast array of scaffolds, form systems. (*see photo 11*)

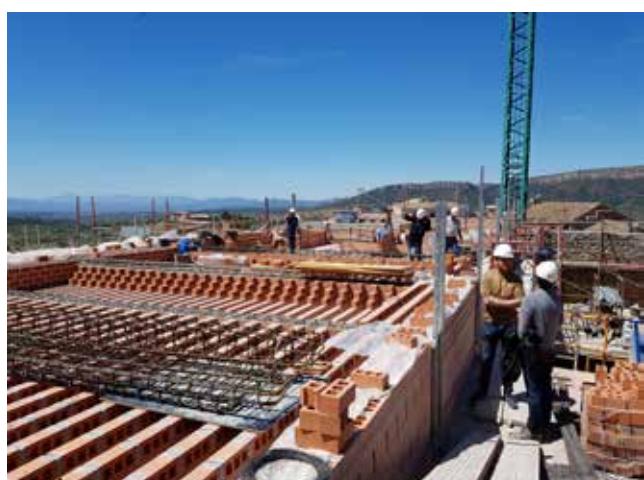
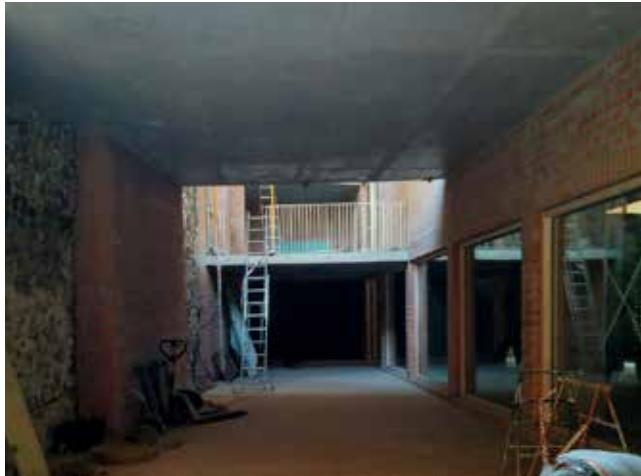
Once the building erection was complete, the east roofing elements were constructed. It is worth pointing out that the vaults roofing is flooded by water and in two distinct levels, where depending on the time of day water flows between both levels. Also, the roofing of the passageway is filled with vegetation and stepped at different levels, so that water can flow from one to the other. (*see photos 12, 13*)
